MERTON COLLEGE CHAPEL, OXFORD, OXI 4JD
QUINQUENNIAL INSPECTION REPORT 2022
ISSUE 01
FEBRUARY 2022

Survey prepared by: Alex Jeremy, RIBA AABC
Purcell Architecture Limited

Dates of inspection: 9th November 2021,
23rd November 2021

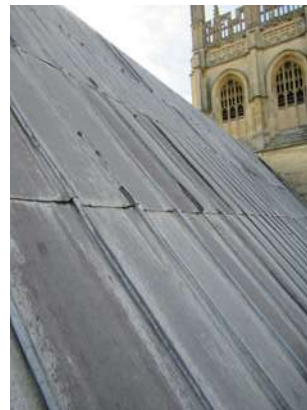
Fig. 6 Choir roof north slope

Element		Condition
EI External & Roofs		
EI.1 Roof Coverings And Gutters		
EI.1.1 Choir – North Slope	Leaded covering with date 1773.	The condition of the leadwork is fair. Some poor-quality repairs have been made in the past – see figs. 5 & 6
	There are four separate sheets between ridge and gutter. The size of the individual sheets is considerably greater than recommended, being about 2.6m in length. It was reported that the lead sheets slip occasionally.	The flashings which cover the junction between the east gable and the lead sheeted roof appear insecurely fixed – see fig. 7
	It appears that the last bay next to the east end has been replaced, possibly at the same time as external masonry repairs.	See fig. 7
	Catch pit to each parapet outlet and hopper. Gutter ‘duck’ boards to lead-lined parapet gutter.	Hoppers appear in good condition – see fig. 8. Some build-up of debris to catch pits – see fig. 9. Some build-up of debris to gutter ‘duck’ boards – see fig. 10.

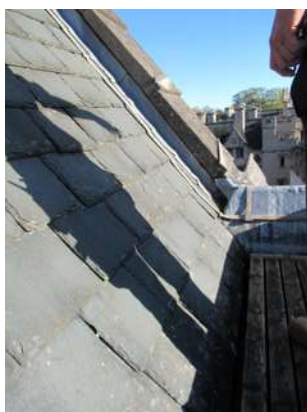
Fig. 11 Choir roof south slope

EI.1.2 Choir – South Slope	The roof is covered with Westmoreland slates.	All in good condition – see figs. 11 & 12
	Roof falls to a lead-lined parapet gutter lined in timber gutter ‘duck’ boards with further timber balustrading at access to gutter.	Some evidence of decay to timber – see fig. 13. Otherwise appears in good condition. Timber balustrading is decayed – see fig. 15.
	Lead parapet gutter outlets feed to lead hoppers.	Appear in good condition. Lead outlets potentially encourage run-off to miss hopper – see fig. 14
		Routine maintenance sufficient to replace occasional slipped slates and to ensure parapet gutters and outlets are free of debris.
EI.1.3 South Transept – East Slope	Roof is covered in Westmoreland slates.	All appear in fair condition - see figs. 16 & 17
	Lead lined parapet gutter with fibreglass gutter ‘duck’ boards over.	Leadwork in good condition – see fig. 17

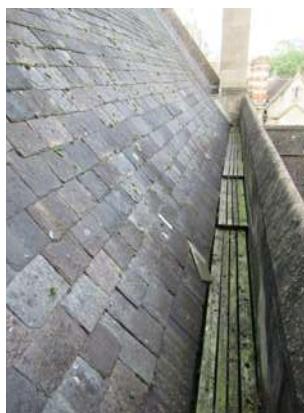
Fig. 20 North transept roof east slope

EI.3 Parapet Gutters Generally		
	<p>The leadwork is generally in good condition.</p> <p>The ‘duck’ boards are aging and slippery.</p> <p>The wicket gate at the south-east corner of the Tower is collapsing and needs to be replaced.</p>	See fig. 20. Routine maintenance is sufficient to keep the catch pits clear of debris.

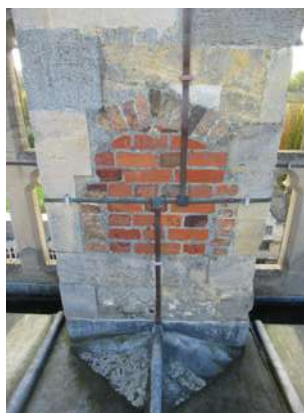
Fig. 26 Tower roof

Element	Condition
EI.4 Lightning Protection	
Lightning conductor tapes are laid to all parapets, finials and gable copings.	See fig. 26. It is understood that the system is regularly inspected by Bacon.
EI.5 Roof Void Over the Choir	
Access is via a small opening in the wall of the adjoining passage. This is awkward and the inspection was limited to the area that could be seen from the passage. It was noted that there is rockwool or fibreglass insulation to the underside of the slates on the south slope. The north slope is boarded to the underside of the lead, with no insulation. A smoke detector has been installed within the roof void.	See fig. 42. There is potential to add insulation to the underside of the north slope.
EI.6 Timber Structure Generally	
The roof structure appears to be original, having large unmachined timbers.	Some signs of beetle infestation were noticed, but a detailed inspection is necessary to confirm the extent of any damage and whether it is active.

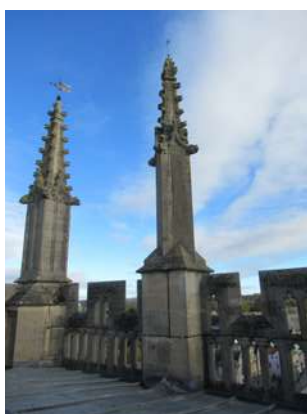
Fig. 27 Tower roof

Element	Condition
El.1.4	Roof is covered in Westmoreland slates	All appear in good condition – see fig. 16
South Transept – West Slope	Roof falls to an eaves gutter sat on string course which feeds to lead hoppers and downpipes	Appears in good condition – see figs. 16 & 27
El.1.5	The roof is covered with Westmoreland slates with lead flashings.	Slates are in fair condition – see figs. 19-21. There are about 20 slates which are either missing, displaced or tagged in position with metal strips. Flashings appear in good condition – see fig. 21.
North Transept – East Slope	Roof falls to a lead-lined parapet gutter.	Gutters appear in fair condition; however gutter 'duck' boards show signs of decay and cause considerable build-up of debris – see fig. 20.
	Stone spirelet to north-east corner	In good condition – see fig. 22
El.1.6	The roof is covered with Westmoreland slates. It falls to a lead-lined parapet gutter.	Gutter not accessible, however, slates appear in fair condition with likely some slipped slates. Gutter likely has some build-up of debris – see fig. 18

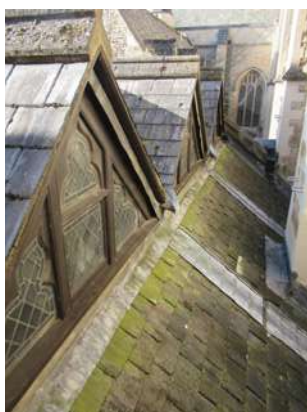
Fig. 29 Sacristy roof north slope

North Transept – West Slope	Stone spirelet to north-west corner	Likely in fair condition.
El.1.7	The roof was re-leaded in 1981 as confirmed by lead inscription. The leadwork gutter on each side falls to an outlet at each end of the gutter.	Leadwork all in good condition. No defects or outstanding maintenance were noted. Gutters largely free of debris. See figs. 23-26
Tower Roof	Stone spirelets to each corner and midspan	All appear in good condition with only minor defects noted – see figs. 27-28
El.1.8	There are three gablets on the upper part of the roof containing triangular windows with leaded lights.	In overall fair condition – see fig. 29. The leaded lights have some cupping – see fig. 33
Sacristy – North Slope	Welsh slates to upper gabled slopes. Westmoreland slates to lower slope.	There are some slipped slates, early signs of timber decay and perished mortar at the junction of the slates with the ends of the gablets – see fig. 29

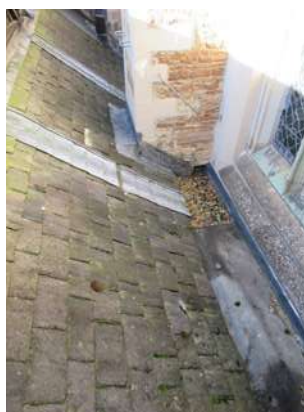
Fig. 30 Sacristy roof south slope

The lower roofs fall to a lead-lined gutter. Valley gutters between gablets outlet to lead runners laid over slates to lead valley gutter with catchpits.	The lead-lined catch pits are not easily accessible except with ladders and are prone to blockage – see figs. 30 & 31
	Lead valley gutter to west elevation.	In fair condition with some build-up of debris – see fig. 34

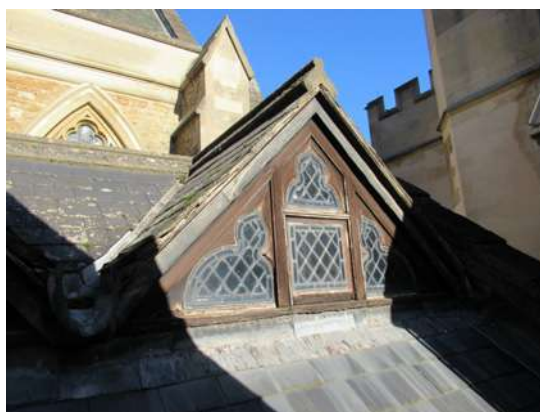
Fig. 36 Sacristy roof south slope

Element	Condition
EI.1.9 Sacristy – South Slope	There are three gablets on the upper part of the roof containing triangular windows with leaded lights. The lower roofs fall to a lead-lined gutter.	<p>In overall fair condition – see figs. 35 & 36. This slope is noticeably more decayed than the north side.</p> <p>There are some slipped slates, signs of timber decay and perished mortar at the junction of the slates with the ends of the gablets – see fig. 40.</p> <p>The leaded lights have some distortion, though less than on the north side – see figs. 35 & 36.</p> <p>The lead-lined catch pits are not easily accessible except with ladders and are prone to blockage – see fig. 37. Lead flashings appear in good order for the most part – see fig. 39 – but with some considerable areas of decay to rainwater management installation – see fig. 38.</p>
EI.2 Stone Staircases		
	A spiral stone staircase is attached to the south-east corner of the south transept. It rises from ground level to the level of the main roof. A further spiral stone staircase at the north-east corner of the tower rises from this level, passing the bell chamber to the tower roof level. The same staircase provides access to the parapet gutter which runs along the north side of the choir roof.	<p>The stone staircases are in good condition for their age – see fig. 41</p> <p>Rope handrails have been installed since 2000 to improve their safety.</p> <p>Routine maintenance is required to keep them swept clean and clear of any debris.</p>

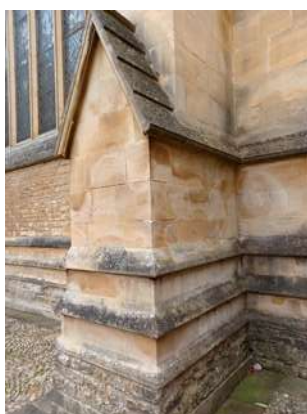
Fig. 50 Choir east elevation

EI.8.3 Front Quad	The front quad is bounded by the Choir: east elevation.	See fig. 50.
	The portion of the Front Quad adjacent to the Chapel is laid in cobbled setts with inset stone flags to delineate pathway from Merton Street/Porters Lodge to the Mob Quad.	Hard landscape finishes appear in good order. There is some evidence of discoloration and moss build-up, however, the area adjacent to the Choir: east elevation appears to drain well – see fig. 110.

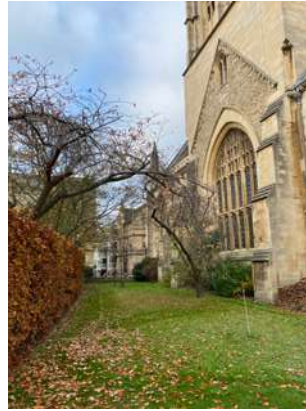
Fig. 73 Ante-chapel west elevation

Element	Condition
EI.7.IIW Tower: West Elevation	This elevation would traditionally have been abutted by the roof of the Nave, unbuilt.	See figs. 73, 75, & 95.
	Façade of coursed ashlar limestone separated by string courses. The façade is punctuated by buttresses of coursed to each corner and mid-span and quatrefoil (one of which is open) and grotesque and gargoyle entablature to the parapet and spirelets to the tower corners and mid-span, linked by decorative castellated balustrades.	There appear to be some open joints to the stonework. It is not immediately apparent why one quatrefoil to the entablature is open, perhaps for ventilation. Some weathering is apparent to the balustrades, spirelets, string courses, and steps to buttresses.
	There are 2 arch-head windows of the same size with stone tracery. Lower third of window apertures are blocked in stone to cover the c.C20 bell frame. Timber louvres are present to the central third of window apertures.	These appear in good condition with instances of new stone apparent. Stonework to the window aperture lower third appears reasonably discrete and in good condition. Louvres show signs of damage related to age and exposure to weather.

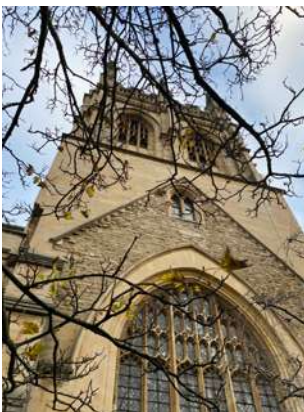
Fig. 74 Ante-chapel west elevation

<p>2no substantial stepped and coped buttresses of ashlar faces and returns to each side of window.</p>	<p>Evidence of water staining to stonework, possibly from free discharge of rainwater from tower roof. Some evidence of spalling stone and poor pointing – see figs. 74 & 76.</p>

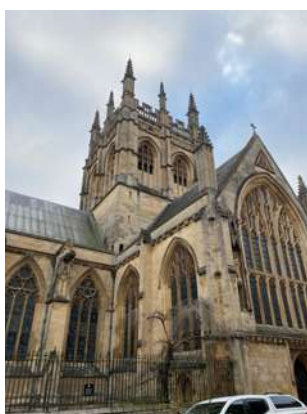
Fig. 92 North transept east elevation

<p>Small timber door leads to north transept</p>	<p>Good condition with some localised wear noted - see fig. 92</p>

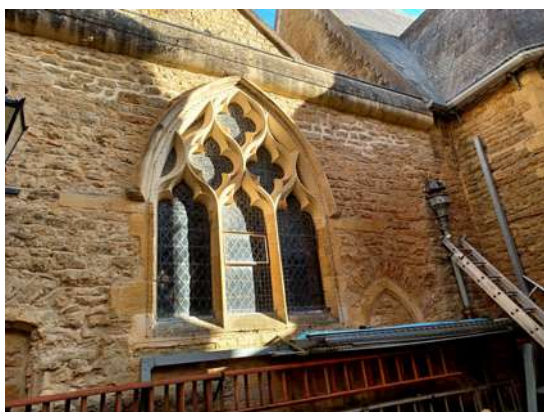
Fig. 100 Sacristy west elevation

Element	Condition
EI.7.13 Sacristy: West Elevation	<p>This façade faces the Maintenance Yard which occupies the space between it and the north elevation of the North Range to the Mob Quad and is adjacent to the Choir: south elevation and the South Transept: east elevation.</p>	<p>See figs. 100 & 101</p>
	<p>The yard is accessed via an arch-head timber door in the wall to the north extent of the Mob Quad. The yard is surfaced partly in concrete, partly with stone setts. Bird netting is installed at high level across the yard.</p>	<p>See External Areas.</p>
	<p>Façade of rough-faced limestone with substantial stone cornice to upper and plinth to lower. 2no blocked doorways are present.</p>	<p>Stonework and pointing in good condition with instances of recent new pointing – see fig. 101.</p>
	<p>There are two arch-headed windows with matching stone tracery of three quatrefoils. Bird mesh to each – see also bird netting across Maintenance Yard.</p>	<p>See also windows. Both in good condition with evidence of stone repairs. Some poor pointing. Evidence of weathering to cills. See fig. 101.</p>

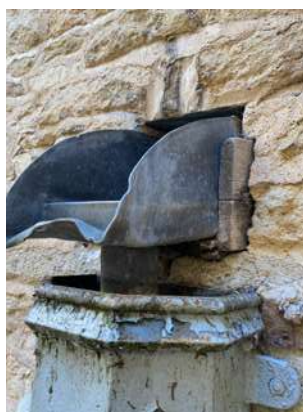
Fig. 101 Sacristy west elevation

<p>Lead outlet spouts pass through the parapet to the north and south of the elevation, respectively, and to a lead hopper and downpipe.</p>	<p>Hoppers and downpipes appear in good condition, although with some signs of age – see figs. 101, 102, & 103. Gullies are blocked – see also external areas and fig. 104.</p>
	<p>A Victorian lantern is fixed to the northern end of the façade. The associated white electrical cable is fixed to the façade, across one of the blocked doorways.</p>	<p>Lantern is in reasonable condition – see fig. 100. Electrical wire is relatively unobtrusive but is affixed across the blocked doorway.</p>
EI.7.14 Vestry	<p>The Vestry passage connects the Front Quad and Mob Quad.</p>	<p>The Vestry (1 Mob Quad) is out of scope and should be included in any wider study of the condition of college buildings.</p>

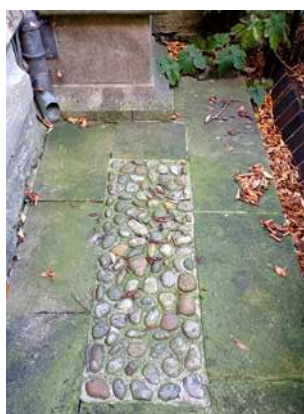
Fig. 105 Burial ground

Element	Condition
EI.8 External Areas		
EI.8.1 Burial Ground	The Burial Ground is bounded by the Choir: north elevation, North Transept: east elevation, walls and high railings to the north and Merton Street beyond, and walls and high railings to the east and Front Quad beyond.	See figs. 43 & 105.
	The Burial Ground consists of lawn with shrubs to north margin and cobbled setts to buttress recesses, separated from lawn by drainage channel.	The landscape is in good order and well-maintained. Cobbled setts show signs of discolouration linked to water run-off – water discharges from the downpipes across this to the drainage channel - see fig. 106. Drainage channel is partially blocked with leaves – see fig. 107. The open channel is noted as a risk to pedestrians on signage and appears to drain well to a gulley to the north-west of the burial ground – see fig. 48 & 49.
	Attached boundary walls and high railings	The railings are in good condition but will benefit from cyclical maintenance and redecoration – see fig. 108. There is evidence of cracking to the coping stone which should be monitored – see fig. 109.

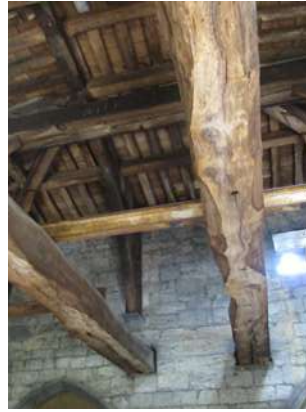
Fig. 119 Bell Chamber

E2 Interior		
E2.1 Bell Chamber		
E2.1.1	The bell is open to the underside of the timber which forms the roof soffit and is crossed by two massive timbers at high level, sat in putlog holes in the masonry	Timbers appear in good condition with minimal discolouration or damage – see figs. 119, 120 & 121
Internal Structural Timber	Metal straps and plates have been bolted to these and other structural timbers	
E2.1.2	Large rough-faced coursed stonework throughout, punctuated by ashlar reveals to openings.	Masonry is clean and largely devoid of defects. Some spalling is noted to the mid-level, perhaps from unsympathetic pointing repairs – see fig. 122.
Internal Masonry	Dates inscribed 1651 and 1773	See fig. 123
E2.1.3	There is a massive wooden bell frame supporting the bells. It appears to be a 20th century structure based on its appearance - machined timber and steel components.	Timber and componentry appear in good condition with no notable instances of localised poor condition – see figs. 126 & 127.

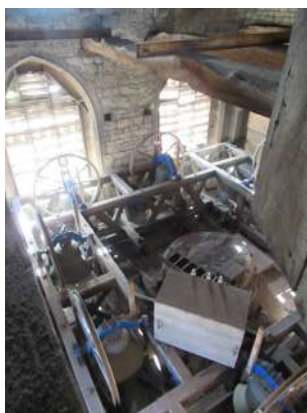
Fig. 124 Bell Chamber

Element	Condition
E2.1.5 Openings	The tower contains two openings in each face, with stone tracery and arched heads.	See figs. 129–132
	On the inside of these openings there are timber louvres and metal mesh screens. The mesh is partly square, partly rectangular.	Mesh is damaged in places – see fig. 124. The timber louvres are in poor condition with numerous slipped, distorted or missing louver blades – see figs. 129-131
	The arched section of each opening, the louvres are closely spaced. In the area below, the louvres are installed in a 'hit and miss' pattern.	This pattern appears deliberate. The modular rail system in to which the louver blades slide allows for the blades to be replaced easily or moved to optimise airflow.
	On the north and west sides of the tower, the openings are covered by boarding.	Presumably installed due to excessive weather ingress. The boarding across the openings is in poor condition – see figs. 127 & 132

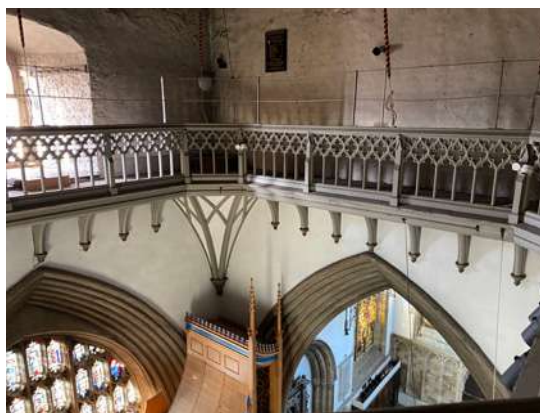
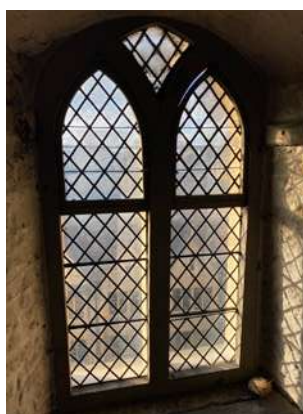
E2.2.2 Internal Masonry	Lime plaster over stonework	Largely good condition with evidence of dirt and dust noted. Some localised areas of likely historic water ingress noted with associated damaged to plasterwork – see figs. 137 & 139.
E2.2.3 Openings	One arch-headed window to the west elevation with simple leaded quarries.	Leadwork, quarries, ferramenta, and stone surrounds are in good condition. One panel of quarries appears to have slipped from the ferramenta – see fig. 140

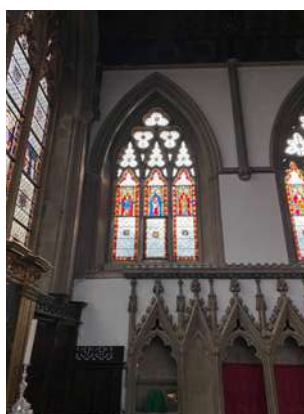
Fig. 145 Choir window tracery

Element	Condition
E2.2.4	The gallery structure sits within the tower, supported on hammer posts and beams.	All in good condition – see figs. 138 & 144
Gallery	Timber balustrade with steel mesh to quatrefoils to upper. Ironwork to upper.	All in good condition. Steel mesh detracts from the balustrade but is likely required for safety. Ironwork to upper appears ineffectual – see figs. 142 & 144
	Timber boarded floor throughout.	In good condition with no noted shakes or deformation – see fig. 141
E2.2.5	Modern electrical switchgear and fire detection system wiring. Bulkhead light over exit.	All appear in good condition and are reasonably discreet – see fig. 143
Fittings		
E2.3 Choir		
E2.3.1	The principal east window comprises fine stone tracery and inset rose window. Stone colonettes to each corner.	All in good condition with no noted localised damage. Reveals display some localised issues of condition. Colonettes appear to have some historic water damage – see fig. 145

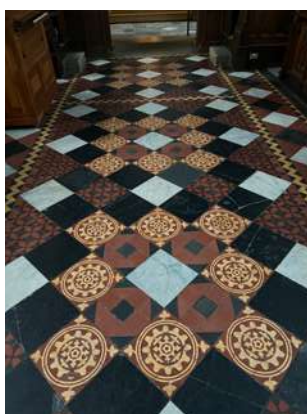
Fig. 162 Choir

Element	Condition
E2.3.2 Choir: Floor	a. Altar floor made up of black and white stone marble tiles with inset ductile iron grates for ventilation.	All in fair condition – see fig. 162. Some instances of damage to the surface are noted, however little requirement to replace. Grates in good condition with instances of missing elements but no requirement for repair – see fig. 175.

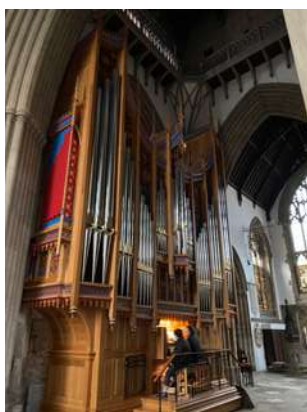
Fig. 182 Ante-chapel, Crossing

Element	Condition
E2.4 Interior: Ante-Chapel		
E2.4.1 Crossing: Floor	Floor of limestone slabs with inset memorials.	Slabs are in good condition however erosion and differential settlement means that the surface as a whole is somewhat uneven – see fig. 182. This should perhaps be reviewed as part of an access audit however realistically there is no pressing need to address this, provided the issue is managed – for example, the most uneven areas to the North Transept are used for chair storage – see item E2.4.9.
	Ramp of modern natural finished oak installed in c.2006/7 and incorporated in to the floor and steps to choir and Wren screen over. Steps which abut ramp apparently installed in c.2014.	The ramp and steps are in good condition and show only minor wear from use – see figs. 181 & 182.
E2.4.2 Crossing: Ceiling	Ceiling is open to the ringing gallery and bell chamber floor above – see item E2.2	See E2.2

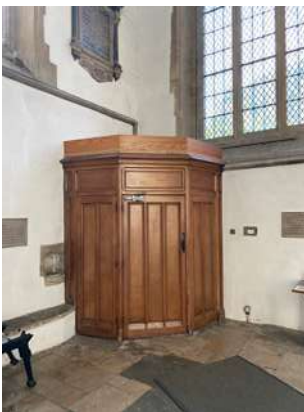
Fig. 186 South Transept

E2.4.5 South Transept: Floor	Floor consists of stone slabs with inset memorials.	Slabs are in good condition however there is some unevenness – see fig. 186.

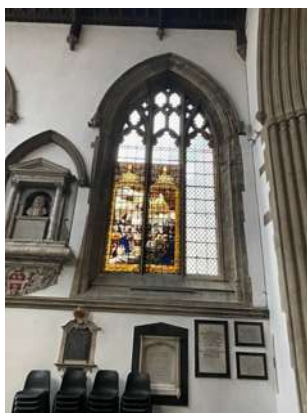
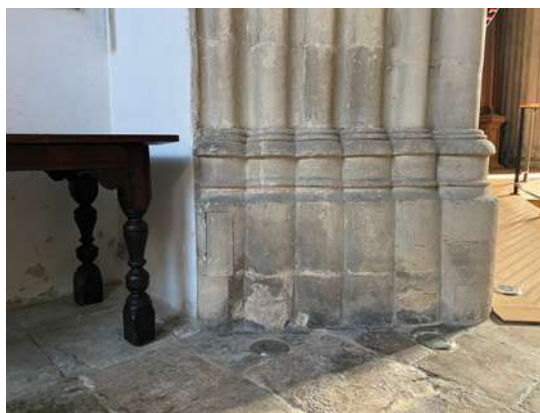
Stone archways and colonettes with stone panelling to each side and surrounding north transept north door.	Some spalled stonework to bases of archways – see figs. 200 & 201. Panelling is in good condition overall with some minor damage to door reveals noted – see figs. 202-203.
E2.4.13 North Transept: Windows	Panels made in 1702 to occupy the east window, have subsequently been transferred to the window openings in the north transept.	These appear in good condition with apertures also in good condition - see figs. 195 & 197-199.
	West elevation: 1 no arch-head window with stone tracery and cill.	Quarries, stonework surrounds and tracery appear in good condition – see fig. 197.
	North elevation: 1 no large arch-head window with fine stone tracery.	Quarries, stonework surrounds and tracery appear in good condition – see fig. 195.
	East elevation: 2 arch-head windows with stone tracery, the patterns of which repeat.	Quarries, stonework surrounds and tracery appear in good condition – see fig. 198-199

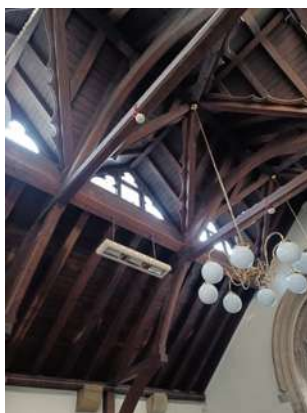
Fig. 204 Sacristy, ceiling

Lighting in the Sacristy was noted as being inconsistent and in need of re-design. Consists of modern brass chandelier fitting	Fair condition – see fig. 204
E2.6.7 Sacristy: building services	Radiant heaters mounted at high level. Inconsistent style of pendant light fittings.	Heating system appears to be inefficient and ineffective. Requires re-design by M&E consultant.
	Wooden cupboard on west wall contains control panels etc.	Power supply fittings to be reviewed by M&E consultant.
	Over-use of electrical extension leads noted.	Exposed cabling and fittings detract from the visual appearance of this room.
E2.6.8 Access Issues	Note stepped access from the Sacristy into the Chapel and from the vaulted lobby area.	No level access possible.

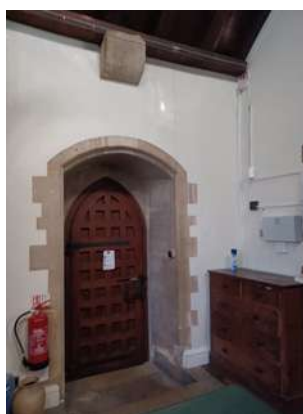
Fig. 207 Sacristy

Element	Condition
E2.6.4 Sacristy: Windows	Two large windows in the east wall containing stone tracery in decorated style, plain leaded lights, pivoting hopper -type ventilator.	All in good condition – see fig 207.
	Window with plain leaded lights in west wall, facing maintenance yard.	Good condition
	Gabled dormer lights contain plain leaded glass.	The leaded lights in the dormer windows show signs of bowing – see fig. 33
E2.6.5 Sacristy: Doors	In south wall, heavy oak panelled door with arched head leads to vaulted lobby.	Good condition – see figs. 208 & 209
	In north wall, three steps up to panelled door leading to Choir.	Good condition with some wear to steps – see fig. 212
	Arched doorways in east wall, one containing an ancient planked door; the other sealed up.	Fair condition – see figs. 210 & 211
E2.6.6 Sacristy: Fittings	The walls of the Sacristy are lined with high-quality timber cupboards.	All in good condition.
